Navigation Systems Research Program

An Investigation of Corrosion Mitigation Strategies for Aging Post-Tensioned Cables

Ernest L. Miller, Barry C. White, Richard W. Haskins,
Robert M. Ebeling, and James A. Evans

January 2017

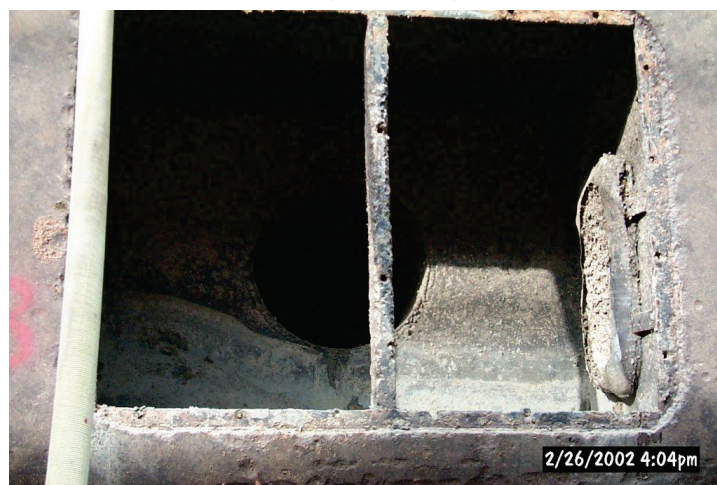
Figure 2.4. Example of anode protecting ship's hull (cathode). This is the U.S. Army Corps of Engineers Dredge Jadwin in dry dock. Note the partially consumed anode (to the right) at the entrance of the engine cooling water intake.

Passive cathodic systems are used where the resistance of the electrolyte is low enough to allow current to flow with little impedance. An example would be ships in salt or fresh water, such as the ones that are shown in Figures 2.3 and 2.4.

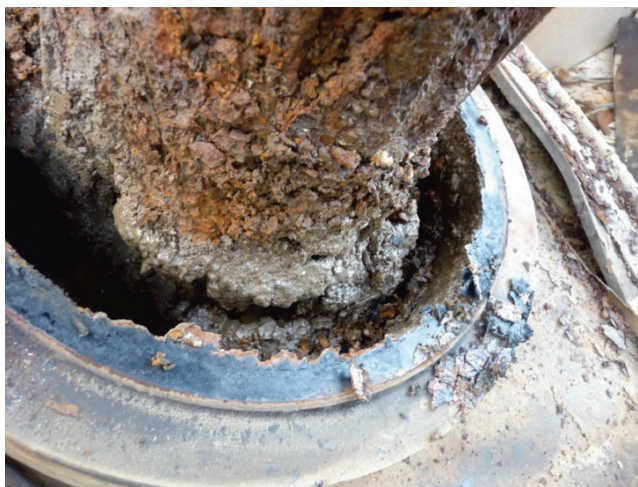
Figure 2.10. Example of accelerated corrosion due to biological agents in existing grease (Ebeling et al. 2013).

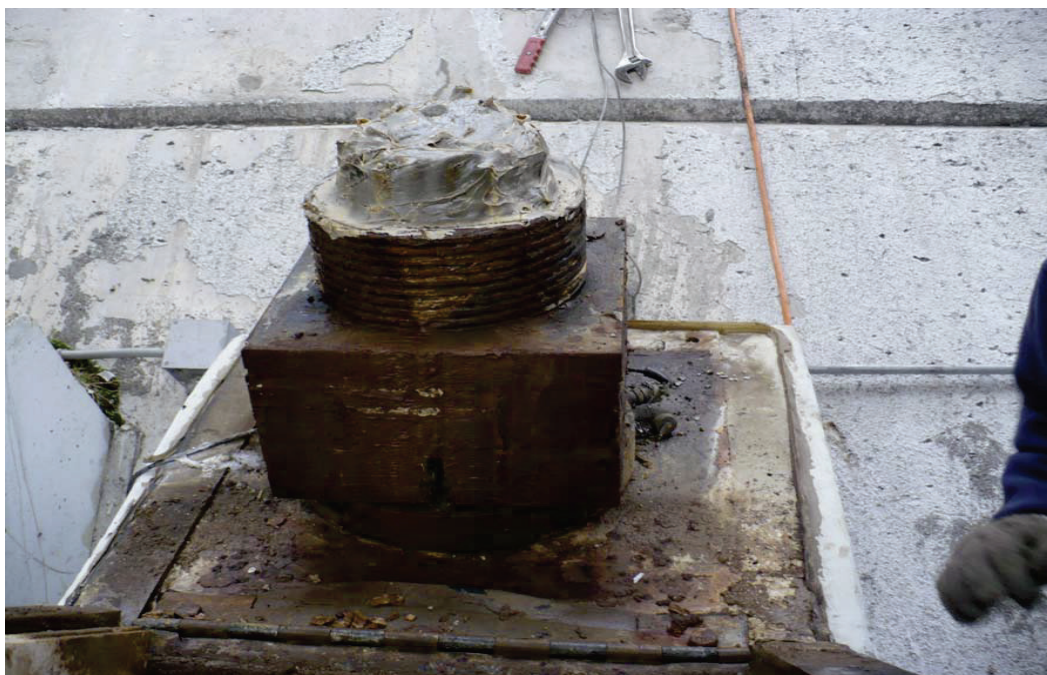
Figure 2.11. Freshly greased anchor head (Cornforth Consultants 2009).

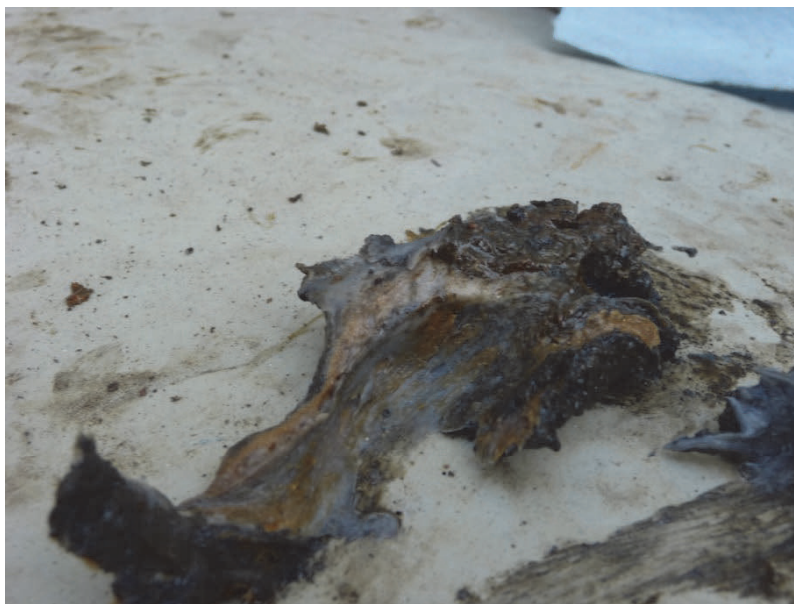
Figure 2.12. Grease with biological growth at John Day lock when anchor head was removed (Ebeling et al. 2013).

Because replacing grease has limited application, new grease only needs to be applied when old the grease has biological growth. This growth aids corrosion by raising pH around the cable, raising the oxygen concentration, and exposing the cable to moisture.
